# Hazard Tree Study

Pacific Crest National Scenic Trail  
Warm Springs Indian Reservation  
July, 2011

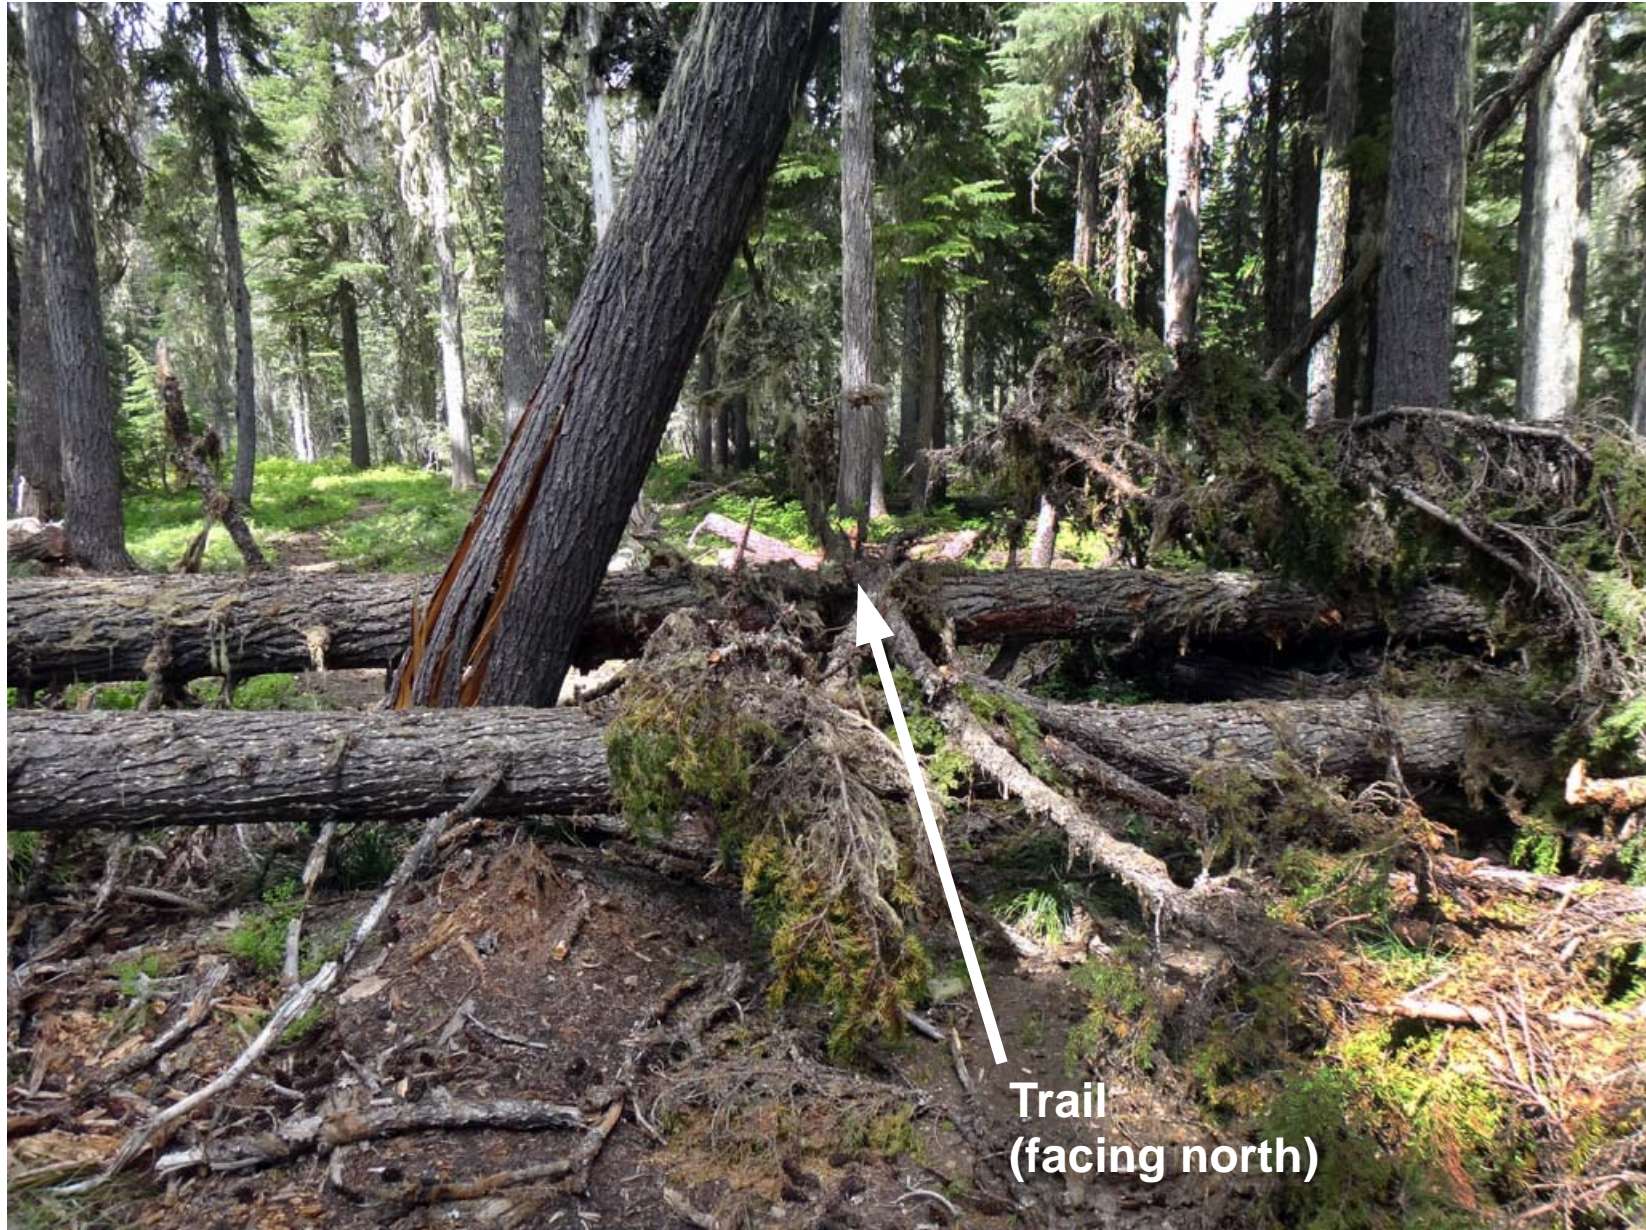
# Proximity of trees to trail

- During the winter of 2010-2011, high winds caused two trees to uproot and fall across the Pacific Crest Trail.
- On their way down, they collided with the crown of a third tree, just a few feet from the trail, causing its trunk to shatter vertically and the tree to lean over the trail.
- The third tree did not fall because its crown became entangled in the crowns of two trees on the other side of the trail.

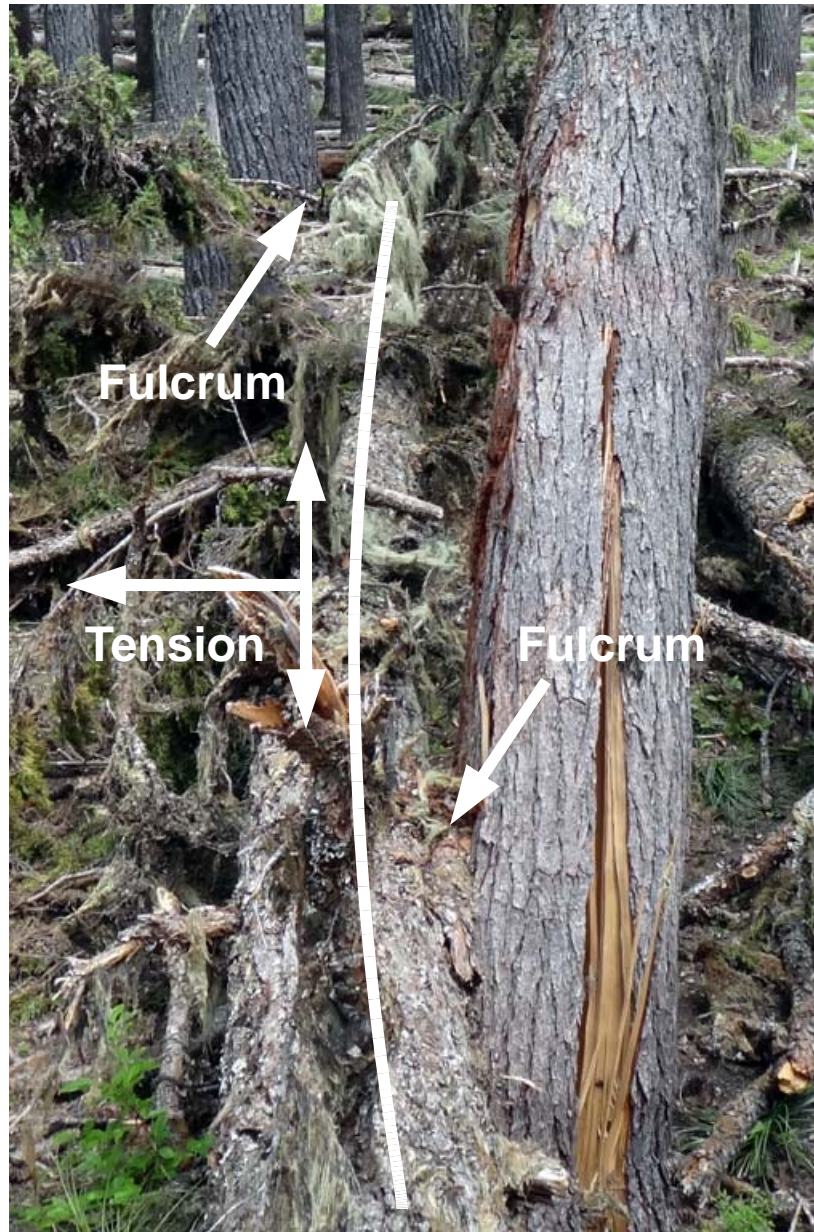
# Side bind

- Because the northernmost blowdown was wedged between the leaner and a sound tree on the other side of the trail, it developed a severe side bind.
- This tree had approximately 6 feet of horizontal bend over a distance of 50 feet.

- A second crew of volunteers + a USFS recreation manager returned to site.
- Decision was made to temporarily reroute trail 15 feet west to avoid leaner.
- Area was cleaned up. Log with side bind severed (with 3 feet of springback). All logs bucked, opening temporary bypass.
- Long-term plan: return trail to original route after subsequent winter winds take down leaner.

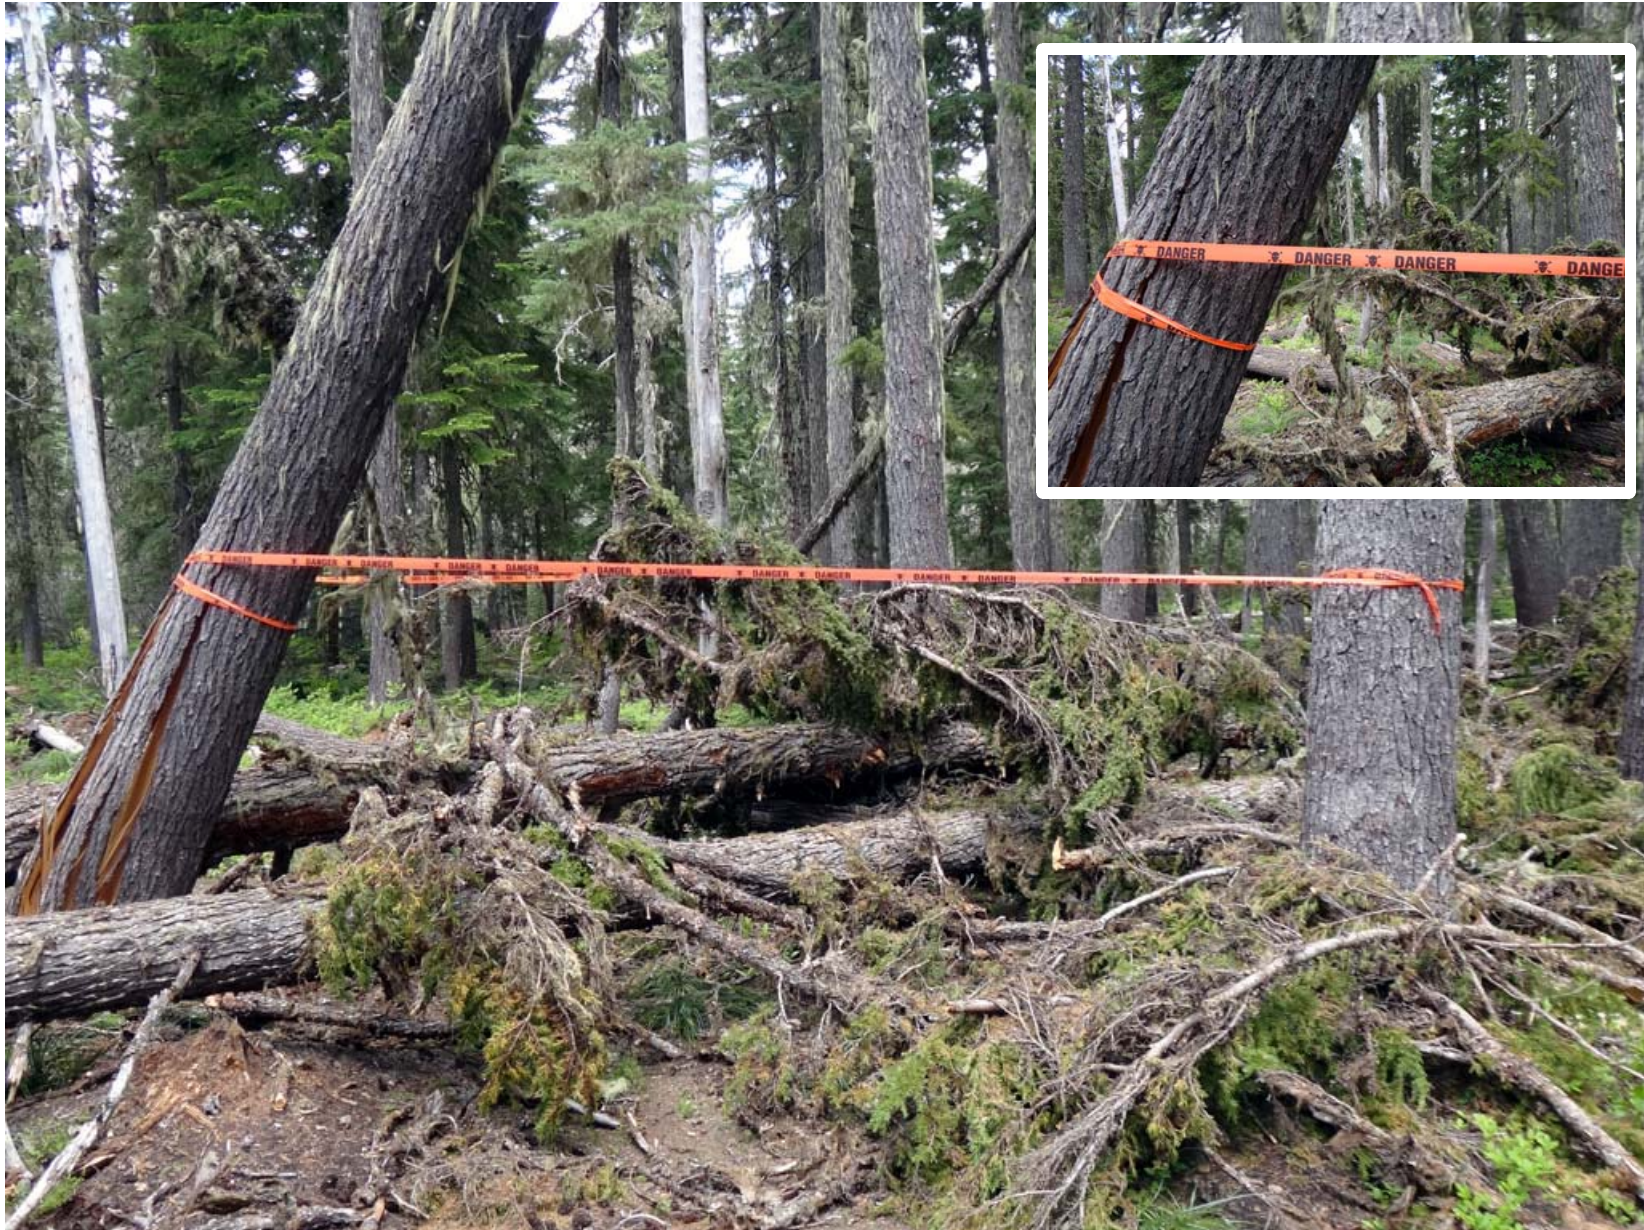
# Marked Hazard Area

- Using established Go/No-Go criteria, the initial volunteer saw crew decided this situation was beyond their capability.
- The crew clearly marked the hazard area and reported the situation to the USFS, the agency managing this section of the PTC.
